CAREC Road Safety Engineering Manuals

I. Road Safety Audit

Case Study 4

A pre-opening stage audit of a 120km section of national highway in the western province

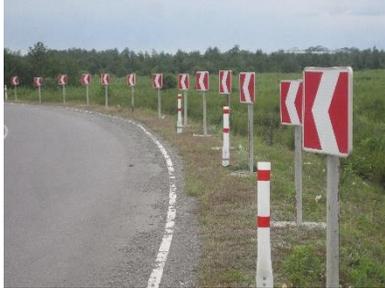
KM.	SAFETY CONCERN	RISK	PHOTO	RECOMMENDATION	CLIENT RESPONSE
SAFETY CONCERNS ALONG THE NEWLY COMPLETED NATIONAL HIGHWAY IN THE WESTERN PROVINCE					
GENERAL	Curves have been delineated inconsistently. Several have too many CAM's installed, some have CAM's in one direction only (the other direction is not delineated), and there are several curves (especially in the hill section) that need CAM's but have none. Such inconsistent delineation can cause drivers to be caught by surprise at sharp curves; run-off-road crashes can result.	HIGH

<p>Photo credit: Phillip Jordan</p>	<ul style="list-style-type: none"> - Undertake a review of the delineation (especially the use of chevron alignment markers CAM's) throughout the length of the highway. - Ensure that <u>all</u> curves with a radius less than 150m have at least three chevrons (with standard spacings) installed on the outside of the curve to face <u>both</u> directions of travel. - Remove redundant CAM's.

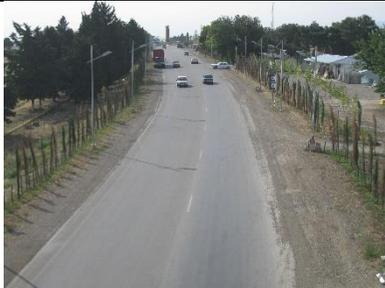
GENERAL	The line marking is clear and correct at the beginning of the newly completed road. However, the edge lines are not continuous in the second half of the highway. Loose gravel and sand from the shoulder is obscuring most of the edge lines that have been installed. This is leading to safety issues due to reduced day and night time delineation.	MED

<p>Photo credit: Phillip Jordan</p>	<ul style="list-style-type: none"> - Sweep the road pavement and the shoulders to keep the road free of gravel and sand, and to make visible the edge lines that have been installed. - Then, complete the edge lines as shown in the Contract drawings. 	
GENERAL	W beam barrier has been installed at each of the six bridges along this highway to shield the side slope on each approach. However, none of these sections of barrier have been stiffened nor correctly affixed to the bridge parapets. There is a risk of "pocketing" into these bridge parapets.	MED

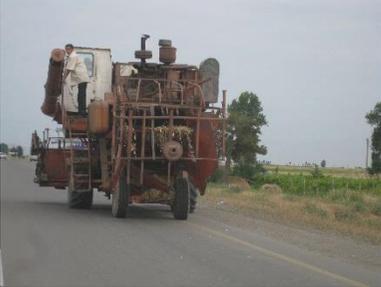
KM.	SAFETY CONCERN	RISK	PHOTO	RECOMMENDATION	CLIENT RESPONSE
KM 10 - 14	At the large cross intersection at Km 10.8 many items of agricultural machinery enter and leave the highway. They travel slowly along the highway for about 3km to either the local petrol station or the next side road junction near Km 13.6. However, the shoulders are unsealed and the drivers try to stay on the highway to minimise dust. Because they are slow moving and large machines they are difficult to overtake. Head on and rear end collisions may result.	LOW

<p>Photo credit: Phillip Jordan</p>	<ul style="list-style-type: none"> - Pave the shoulders of the highway between Km 10+00 and Km 14+00 to a width at least 2m to provide an option for drivers of large machinery to use. - Install advance warning signs on the highway to advise drivers of the possibility of machinery using the road. - Install two street lights at the cross road at Km 11.8 and another two at the side road junction near Km 13+60 to highlight turning vehicles.

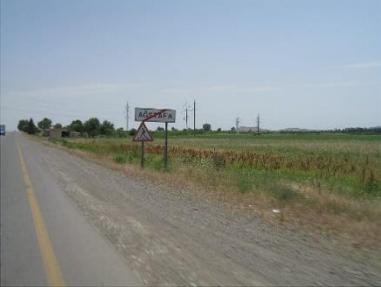
KM 45	There is a school on the right (north) side of the highway near Km 45. It is approximately 600m outside the nearby village and it appears that most of the young children attending the school walk along the edge of the highway from the village. With an unpaved shoulder and nearby long grass children sometimes walk on the road pavement. This exposes them to a risk of a collision with the fast-moving traffic.	MED

<p>Photo credit: Phillip Jordan</p>	<ul style="list-style-type: none"> - Discuss options with the school. - Pave the shoulders between the village and the school (at least 2m wide) or, - Construct an "all weather" footpath (and possibly cycling path) within the road reservation (right side). This off road path should be at least 3m wide and should be signed for pedestrians and cyclists only. 	
KM 60 - 64	There are steep undrivable roadsides in the hill section between Km 60 – 64 (approx.). Some W-beam barrier has been installed but it is too short in four places, leaving unsafe side slopes unshielded. These side slopes are a serious risk to the occupants of errant vehicles. The slopes cannot be "softened" due to the topography. High quality delineation and more safety barrier is needed.	HIGH
