CAREC Road Safety Engineering Manuals

I. Road Safety Audit

Case Study 2

A detailed design stage audit of the reconstruction of a 300km section of the national highway.

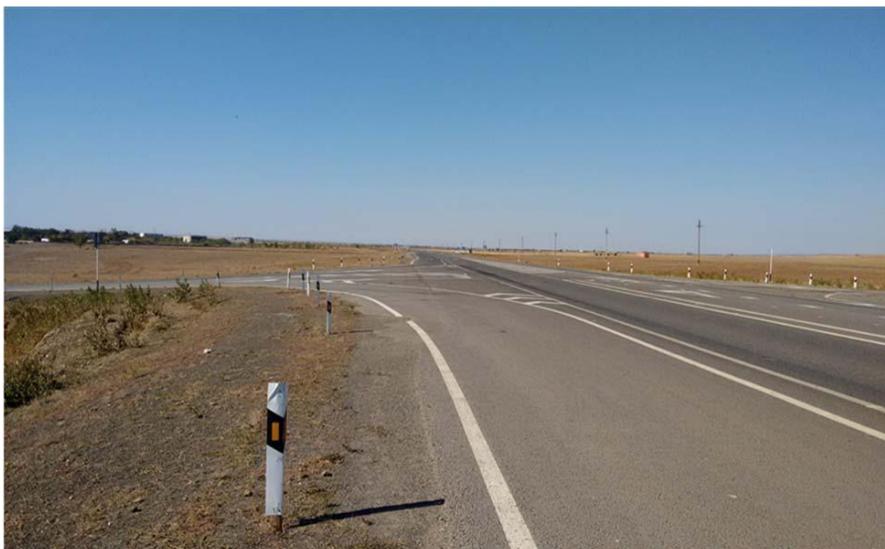
An intersection on a recently rehabilitated section of the A-27, 25km north of the start of the proposed works.

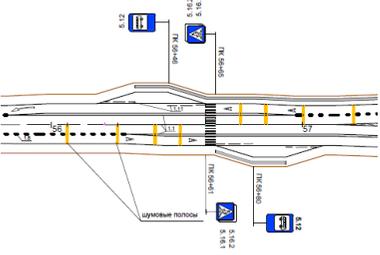
KM.	SAFETY CONCERN	RISK	PHOTO	RECOMMENDATION	CLIENT RESPONSE
SAFETY CONCERNS ALONG THE PROPOSED DUPLICATION OF THE NATIONAL HIGHWAY					
GENERAL	Throughout the scheme, pedestrian crossings have been proposed to link communities with bus stops. In most locations, these crossings straddle four lanes with no refuge for crossing pedestrians. Users of the crossings will effectively have to cross with no control in a single phase. The presence of the second lane will encourage overtaking in the vicinity of the crossings and potentially higher speeds. These combined factors will increase the risk of conflict between pedestrians and vehicles.	VERY HIGH

<p>Source: TOP Geodezia, Almaty</p>	<ul style="list-style-type: none"> - Reduce the carriageway from four to two lanes at these locations. - Provide appropriate lengthened entry and exit tapers to negate the need for the extra lanes. - Any acceleration lanes for adjacent junctions should terminate in advance of the bus stops, not continue through the bus stop location.

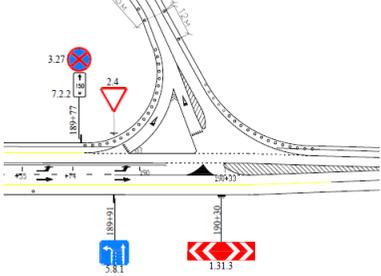
KM.	SAFETY CONCERN	RISK	PHOTO	RECOMMENDATION	CLIENT RESPONSE
	<p>conflicts. It will also increase the risk of vehicles entering the side road at high speed and losing control.</p>

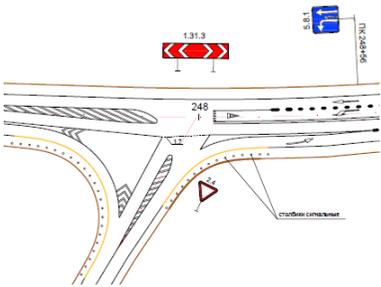
<p>Source: TOP Geodezia, Almaty</p>		
<p>KM 248</p>	<p>A side road joins the mainline at an acute angle here. The exit and entry radii are very relaxed which will increase the entry speeds from the side road. They will also encourage high speed entry movements into the side road. This will increase the risk of “failure to give way” conflicts as well as vehicles potentially entering the side road at high speed and losing control.</p>	<p>HIGH</p>

<p>Source: TOP Geodezia, Almaty</p>	<ul style="list-style-type: none"> - Provide tighter radii to cause drivers to reduce speed on the approach to the mainline and also when entering from the mainline onto the side road. 	
<p>KM 277</p>	<p>There is an existing narrow bridge across a wide river (500m) here. It has large concrete parapets that are roadside hazards. It is the only such bridge along this highway, and as such it may catch some drivers by surprise. The drawings are silent about any safety improvements at or along this narrow bridge. W-beam safety barrier is needed to shield the side slopes and there is a need to delineate the bridge to reduce the risk of side swipe collisions at night.</p>	<p>HIGH</p>

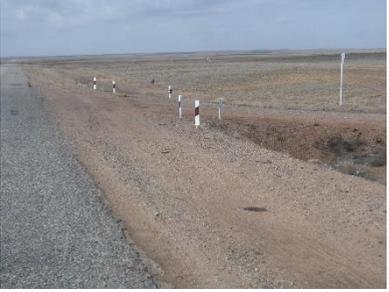
KM.	SAFETY CONCERN	RISK	PHOTO	RECOMMENDATION	CLIENT RESPONSE
<p>KM 297.7</p>	<p>Pedestrians walk along a small side road on the right) from a village to the highway to catch mini-buses. They cross the highway to do this. However, the drawings do not show anything to assist them with their crossing of the highway. Traffic speeds at the location are high and may increase after the rehabilitation. A pedestrian crossing is not appropriate due to the low volumes of pedestrians and the high speed of traffic. A refuge island offers the safest option for all.</p>	<p>MED</p>

<ul style="list-style-type: none"> - Ensure that the safety of these pedestrians is discussed and resolved before the designs are completed. - Consider installing a length of divided road (up to 200m long) with a median that is at least 3m wide to provide a refuge for crossing pedestrians. - Install appropriate warning signs on both approaches – for the median and the pedestrians. - Consider a shelter for the pedestrians.
