CAREC Road Safety Engineering Manuals

I. Road Safety Audit

Case Study 3

A roadworks stage audit of the upgrading of two sections of an international highway.

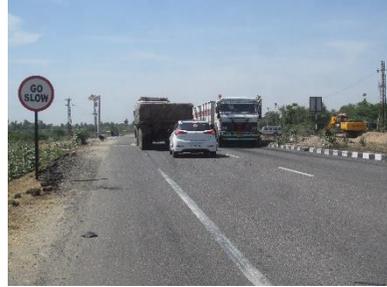
KM.	SAFETY CONCERN	RISK	PHOTO	RECOMMENDATION	CLIENT RESPONSE
From Km 252.100 to Km 256.700	No "Two Way Traffic" warning signs are shown in the TMP to warn/inform drivers in both directions when contra-flow arrangements exist. One "Go Slow" sign is in place but it is too general and it gives no warning of the risk of head on collisions. Allowing drivers to forget they are on a two-way road sets up a high risk of head-on collisions.	HIGH

<ul style="list-style-type: none"> - Redesign the TMP to show the installation of duplicated, reflective "Two Way Traffic" warning signs at spacings not exceeding 500m through the contraflow section of the duplicated highway. - Ensure the warning signs face both directions of traffic. 	
GENERAL	No workers were sighted wearing reflective or high visibility clothing on-site during the site inspections. This is a requirement in the Contract and is an essential matter for personal safety.	MED

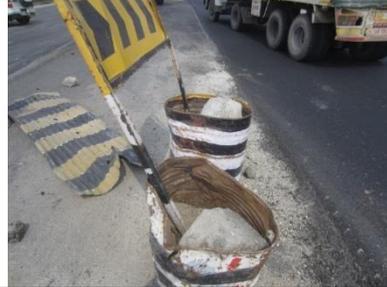
Km 256+200	Concrete filled barrels are being used as delineators and to hold some "Diversion" signs at this work site. These are roadside hazards and are highly dangerous if struck by a small vehicle or a motorcyclist.	MED

<ul style="list-style-type: none"> - Direct the Contractor to remove these concrete filled drums and replace them with conspicuous but forgiving traffic control devices (such as plastic traffic cones, bollards) and reflective metal signs.
